To the Historic Landmark Commission of Austin, Texas:

### **Current State of 1207 E 9th Street**

RE: Structural Integrity Inspection  
1207 E. 9<sup>th</sup> St.  
Austin, Texas 78702

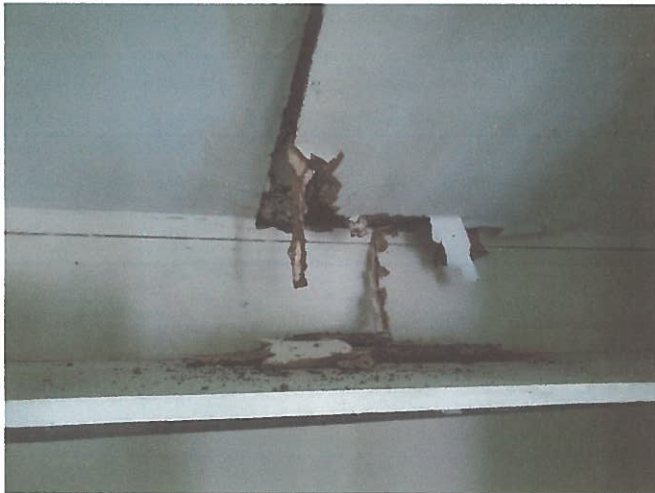
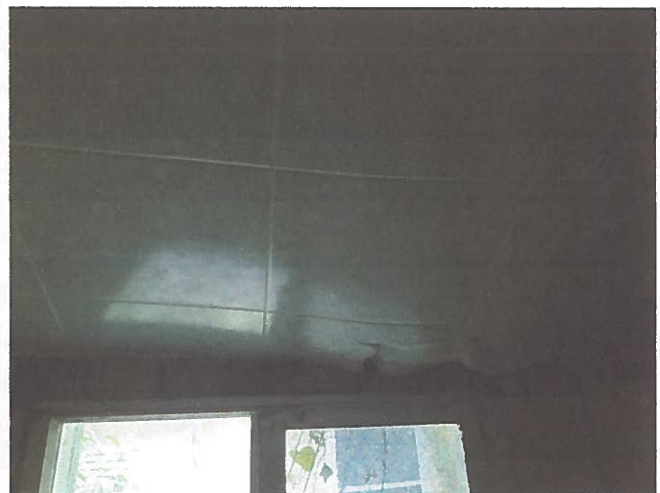
The house was abandoned for a number of years and has not had routine maintenance done. The structural issues have resulted in a lot of movement in the foundation. Because of this, the living room and kitchen have noticeably uneven floors, and there are lots of cracks in the ceiling. The roof is in poor shape and is collapsing in several places.

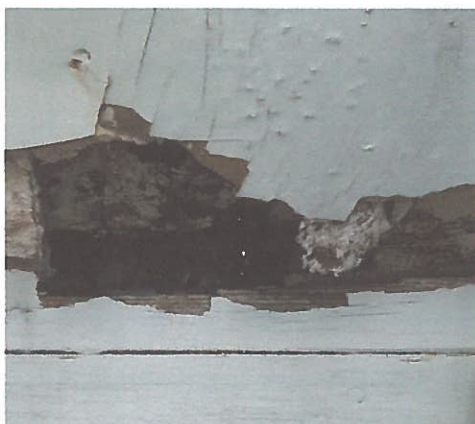
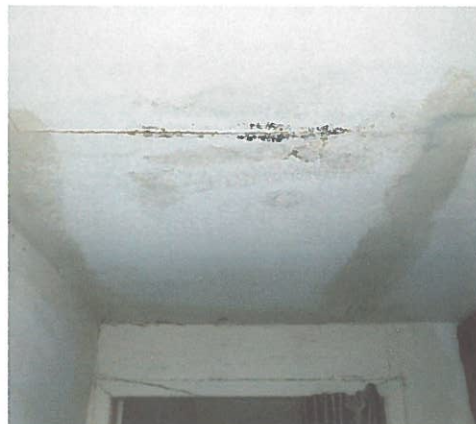
Additionally, there are holes in the walls and roof exposing the inside to moisture and insects.

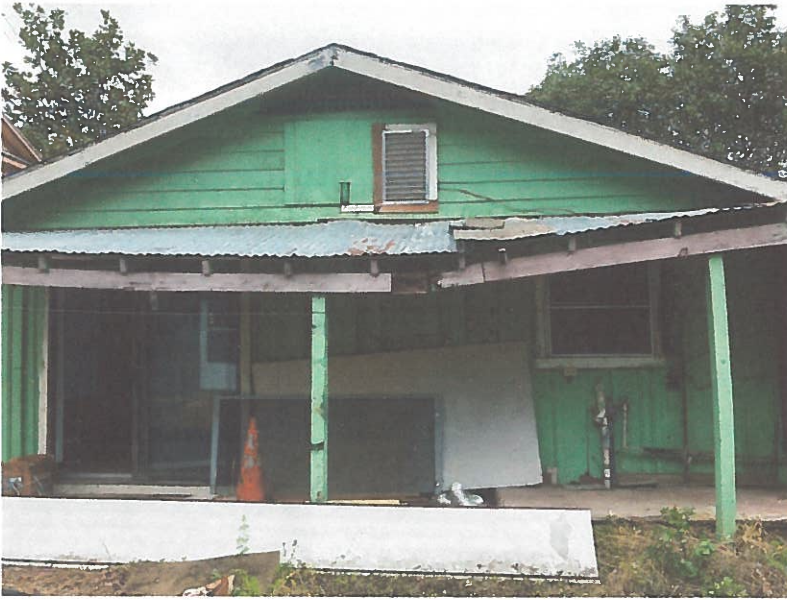
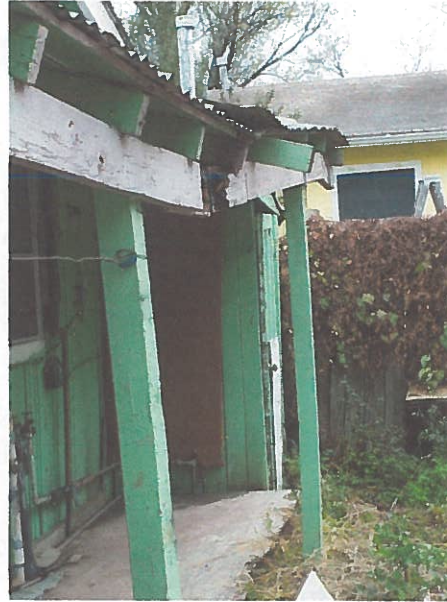
The roof is also collapsing above the back porch.

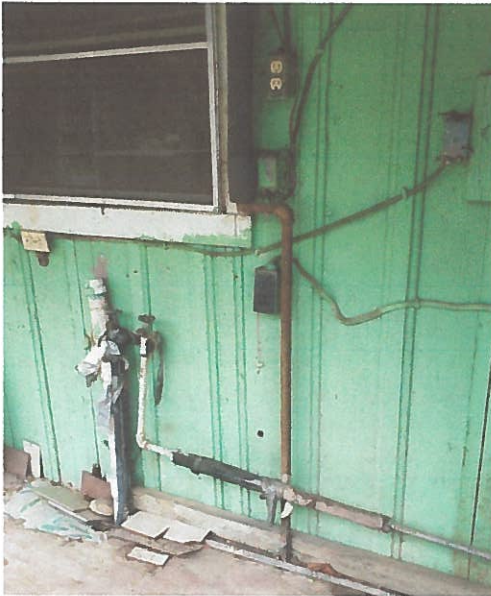
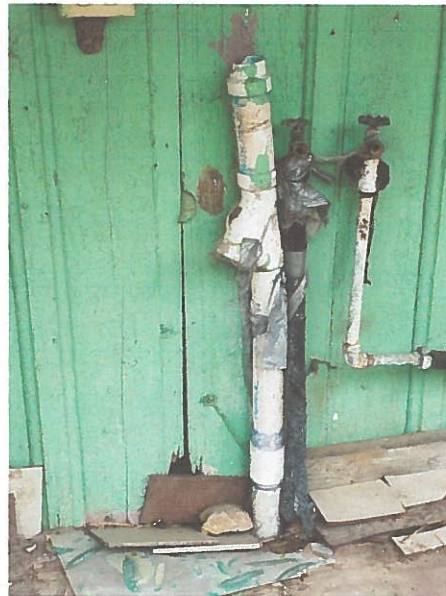
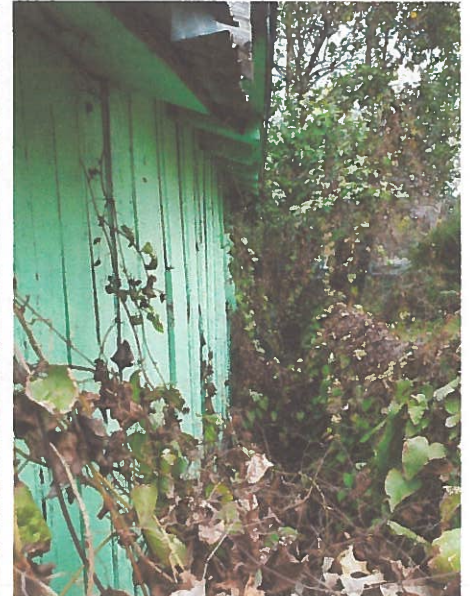
Much of the wiring and plumbing is also not up to code and vegetation has overtaken the external siding

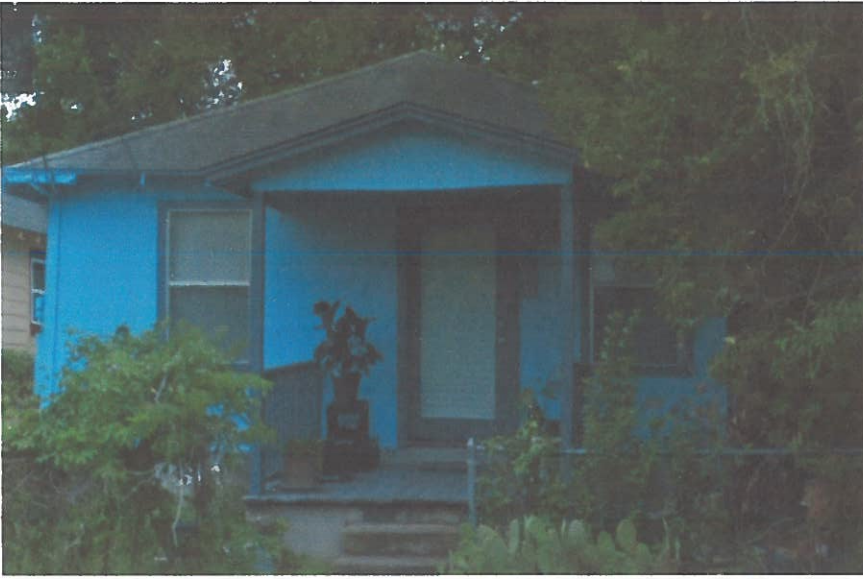
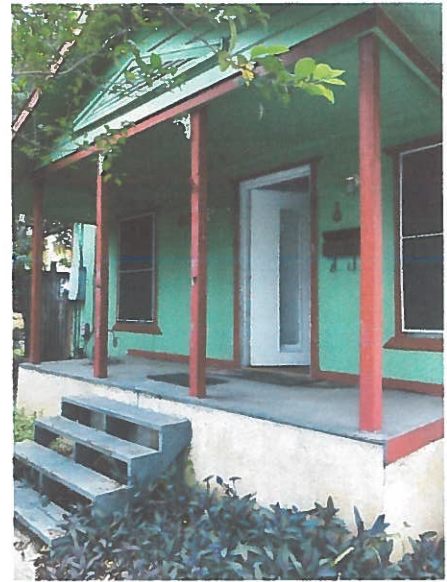
Also, while investigating the history of the house, we discovered that the large front porch is not original to the 1949 construction. We found a City permit to expand the front porch by four feet on both sides in 1995 (permit number: 1995-000372BP). A 1962 Sanborn map shows the house with a small front porch. The other houses in the neighborhood that were built around the same time have much smaller porches as well.

Ex. 1209 E 9th Street, which was built in the same year vs 1207 E 9th Street

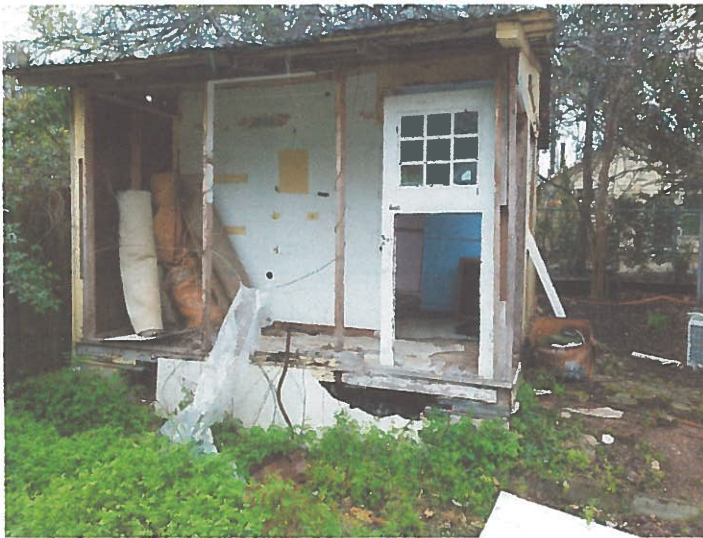
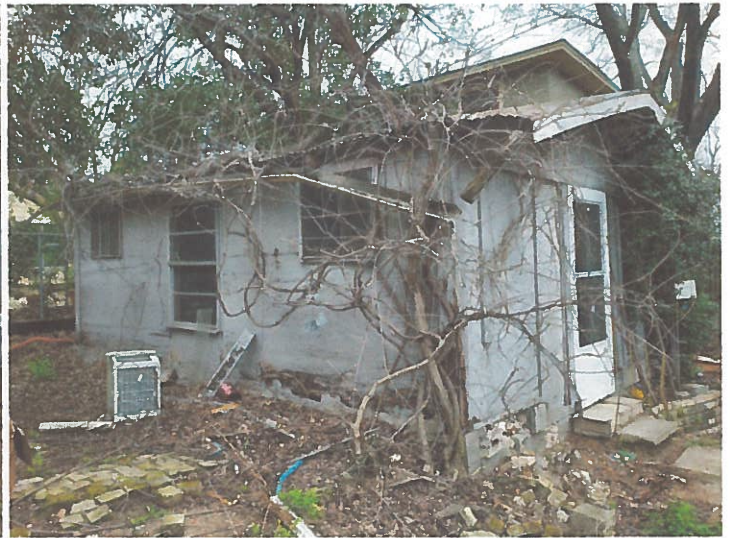
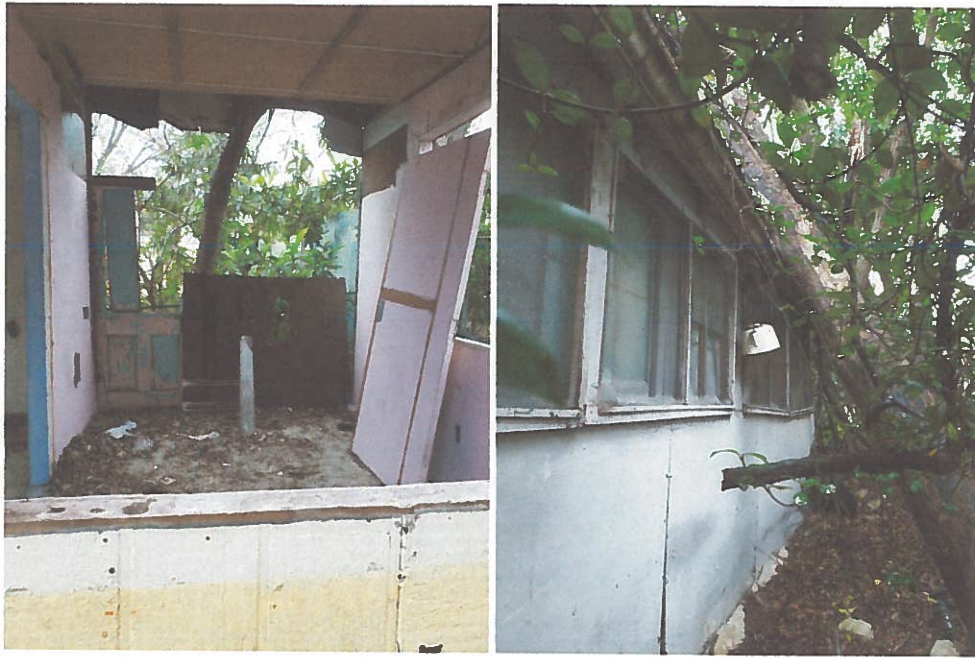
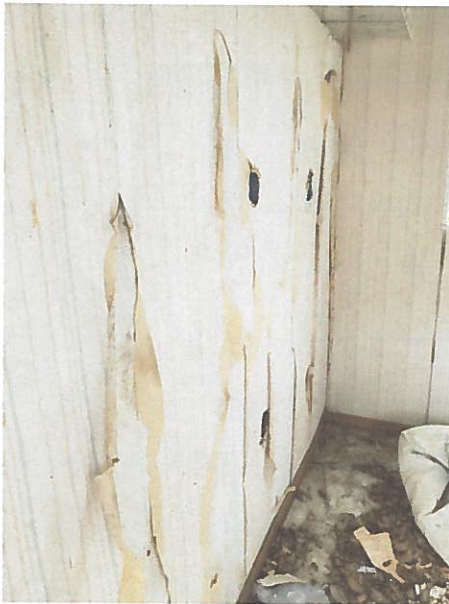
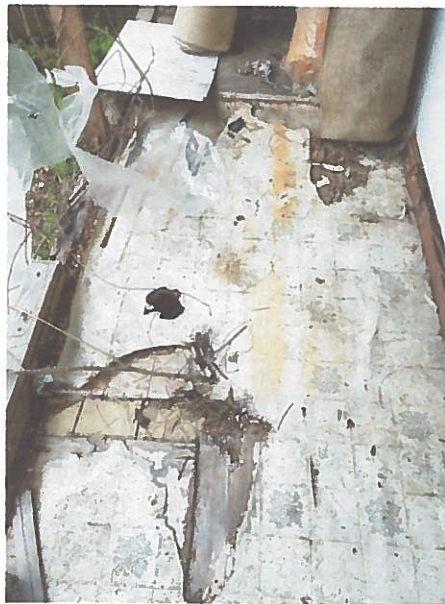
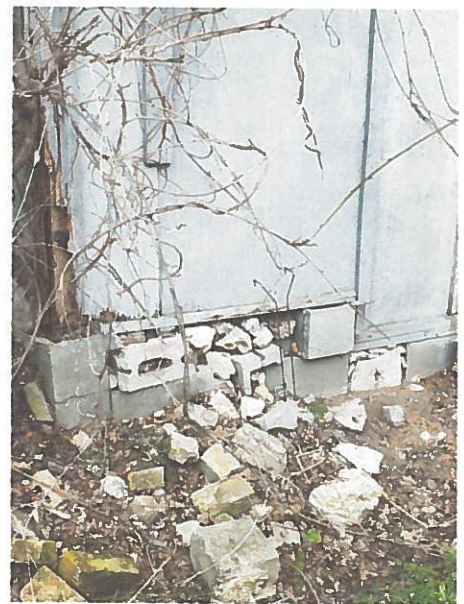
The two sheds in the backyard seem to have been mostly assembled from leftover parts of other building projects and have not been maintained. One is missing walls. A tree has fallen on the other. More photos can be seen in the demolition application.
